ANALOMINK LAKE DAM

PHASE I INSPECTION REPORT

NATIONAL DAM INSPECTION PROGRAM

Name of Dam:	Analomink Lake Dam
State:	Pennsylvania
County:	Monroe
Stream:	Unnamed Tributary of Brodhead Creek
Coordinates:	N41°03.6', W75°13.7'
Date of Inspection:	May 20 and June 1, 1981

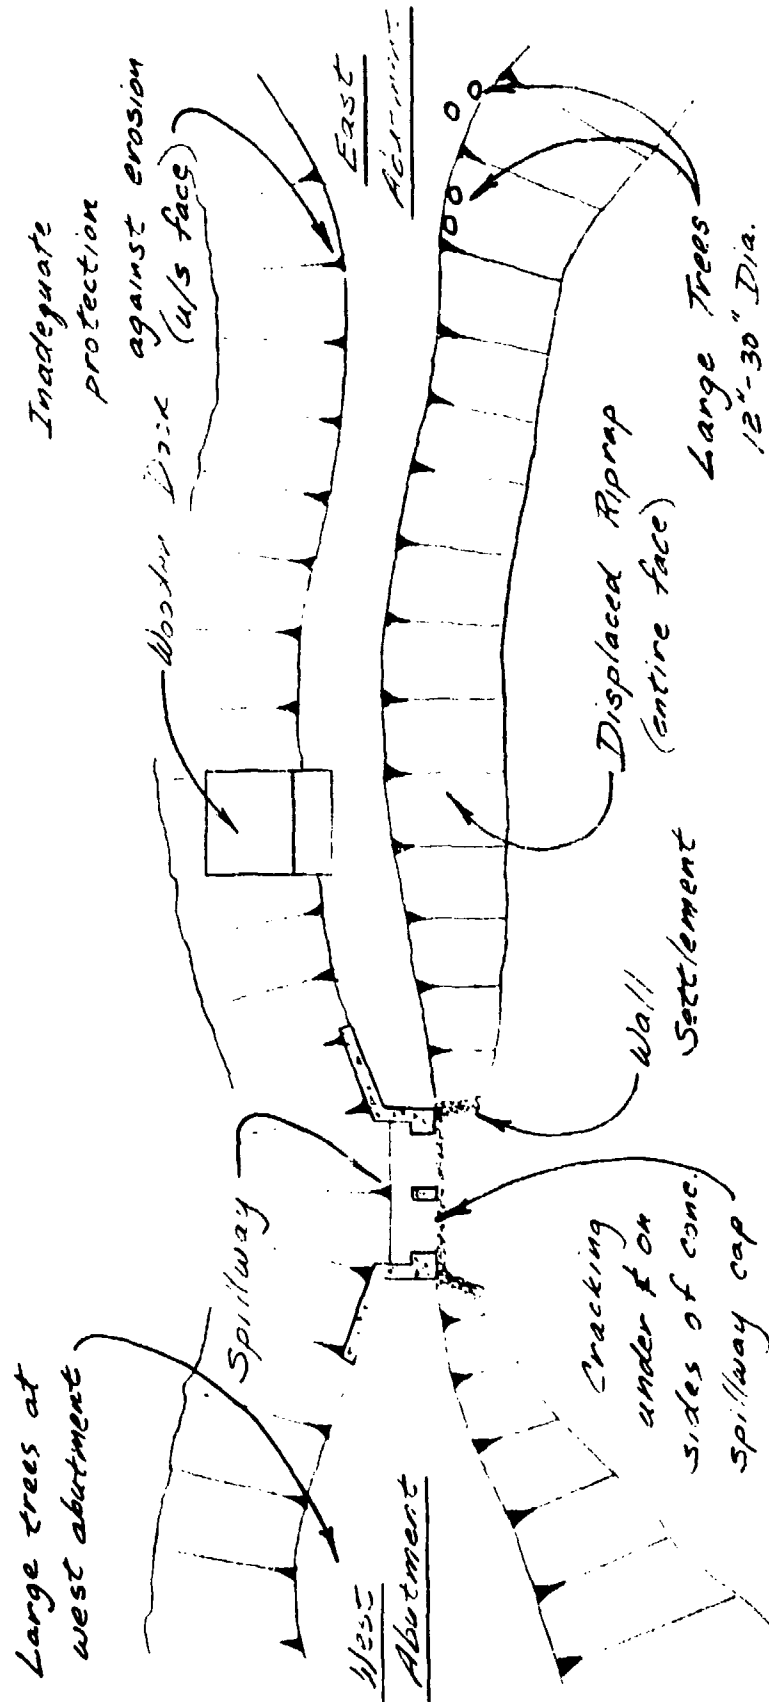
LOCATION PLAN OF DEFICIENCIES
OBSERVED DURING VISUAL INSPECTION
ON MAY 20, 1981

* Much seepage over entire d/s area up to 50 gpm

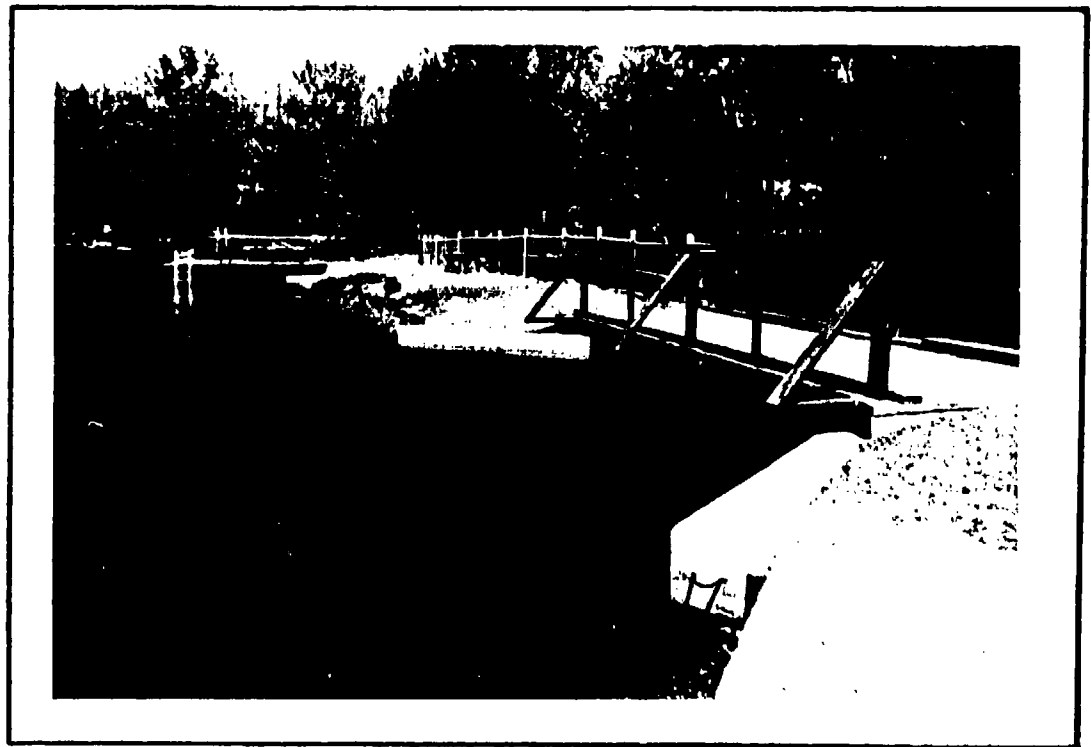
VISUAL EXAMINATION OF	OBSERVATIONS	REMARKS OR RECOMMENDATIONS
CONCRETE WEIR	Concrete cap on stone masonry spillway is spalled. A crack has developed just under the cap.	Repair the crack.
APPROACH CHANNEL	None	
DISCHARGE CHANNEL	Spillway has free fall to outlet channel. (Photo 4, Appendix C)	
BRIDGE AND PIERS	Side and center abutments at spillway are in good condition. 3 year old concrete wingwalls are in excellent condition. (See Photos 2 and 4)

2. INLET CHANNEL FOR THE SPILLWAY AND THE UPSTREAM FACE OF THE DAM. (5/20/81)

Displaced riprap should be
replaced. Small stones on
u/s face should be supplemented
with larger angular riprap.

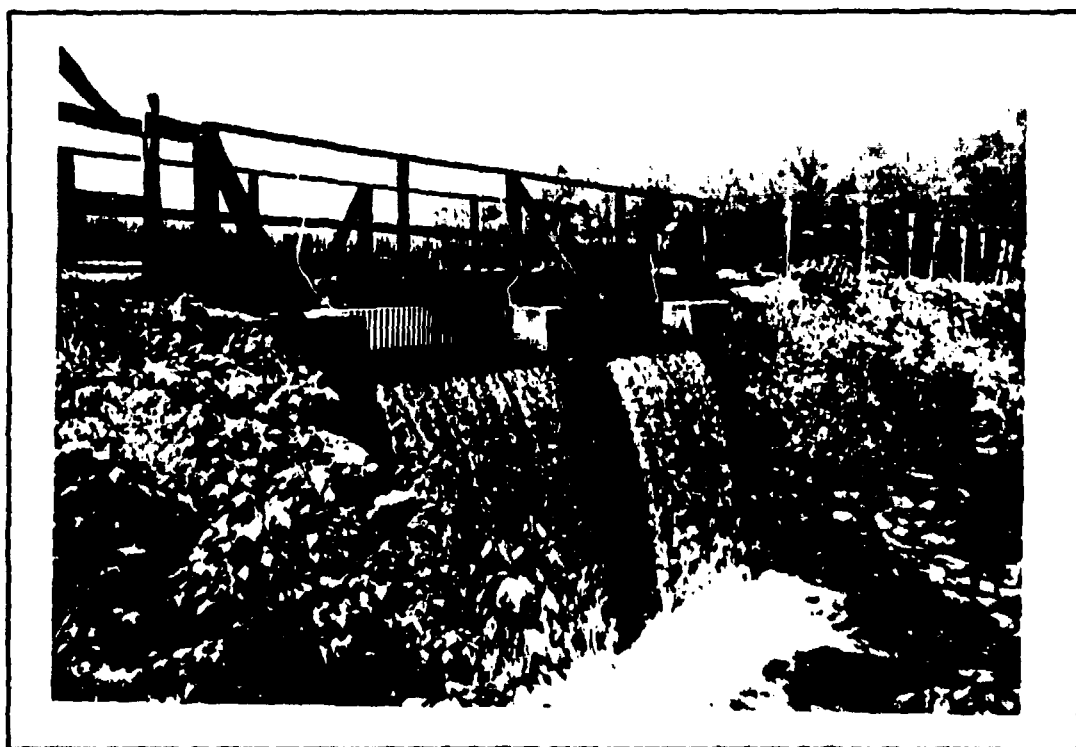
The stone spillway abutment walls located just downstream of the overflow portion appeared to have settled. As a result, some of the stone on the abutment walls have started to slide downstream (See Photo 4, Appendix C). It was also observed that concrete has been placed at the downstream base of the spillway, presumably to prevent erosion due to the force of water flowing over the spillway.

No misalignment observed, except at the east side spillway abutment wall which was shifted slightly. (Photo 4, Appendix C)

4. SPILLWAY NEAR THE RIGHT ABUTMENT.
NOTE THE MOVABLE FISH SCREENS. (5/20/81)

Repair spillway abutment wall.
